# Manhole Inspection Summary

Manhole # S08AA2005MH

**Location** Address: **4131 CREST HEIGHTS RD**

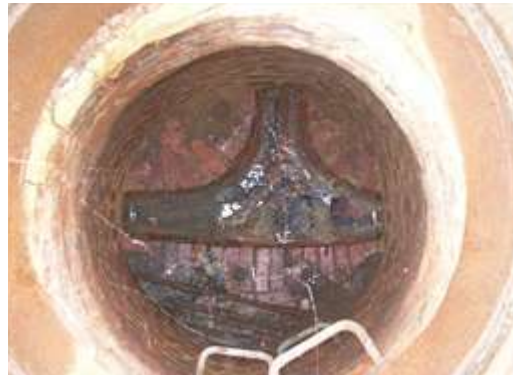
Top View

Evidence of surcharge - Bench debris.  
Channel debris.

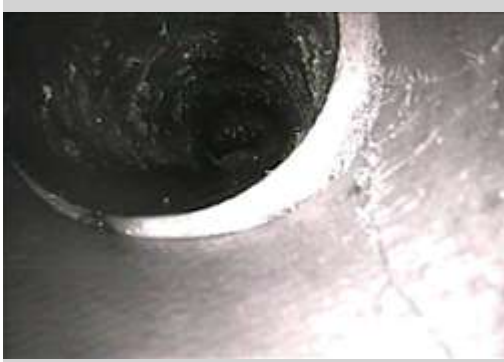
Inside the I6

Offset joint.

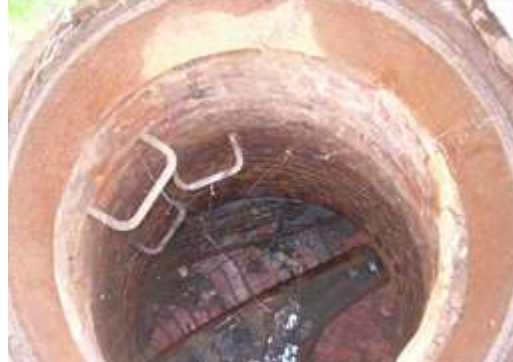
Defect

Frame leaks. Frame offset. Adjustment  
deterioration and infiltration. Barrel  
infiltration - other side.

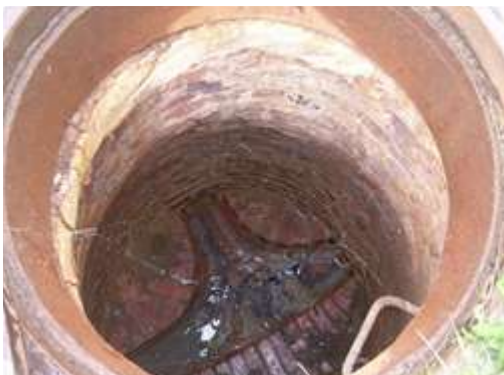
Defect

Frame leaks. Frame offset. Adjustment  
deterioration and infiltration. Barrel  
infiltration.

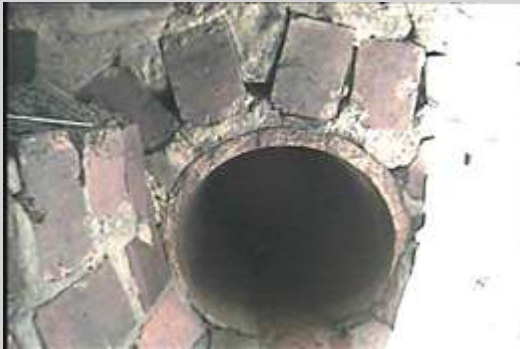
### 8 in. Circular Gravity Sewer Pipe Out @ 12 O'Clock

Barrel deterioration and infiltration.

Infiltration: **Evidence** Pipe Seal Cond: **Cracked**

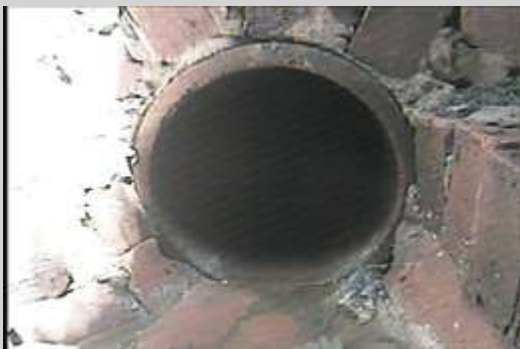
### 8 in. Circular Gravity Sewer Pipe In @ 3 O'Clock

Barrel deterioration and infiltration. Channel deterioration.

Infiltration: **None** Pipe Seal Cond: **Cracked**
